REPORT ON THE RESURVEY OF THE NORTH
THORNE RIVER SALE AREA

Bruce Dinneford
Alaska Department of Fish and Game
Sport Fish Division
May 1976

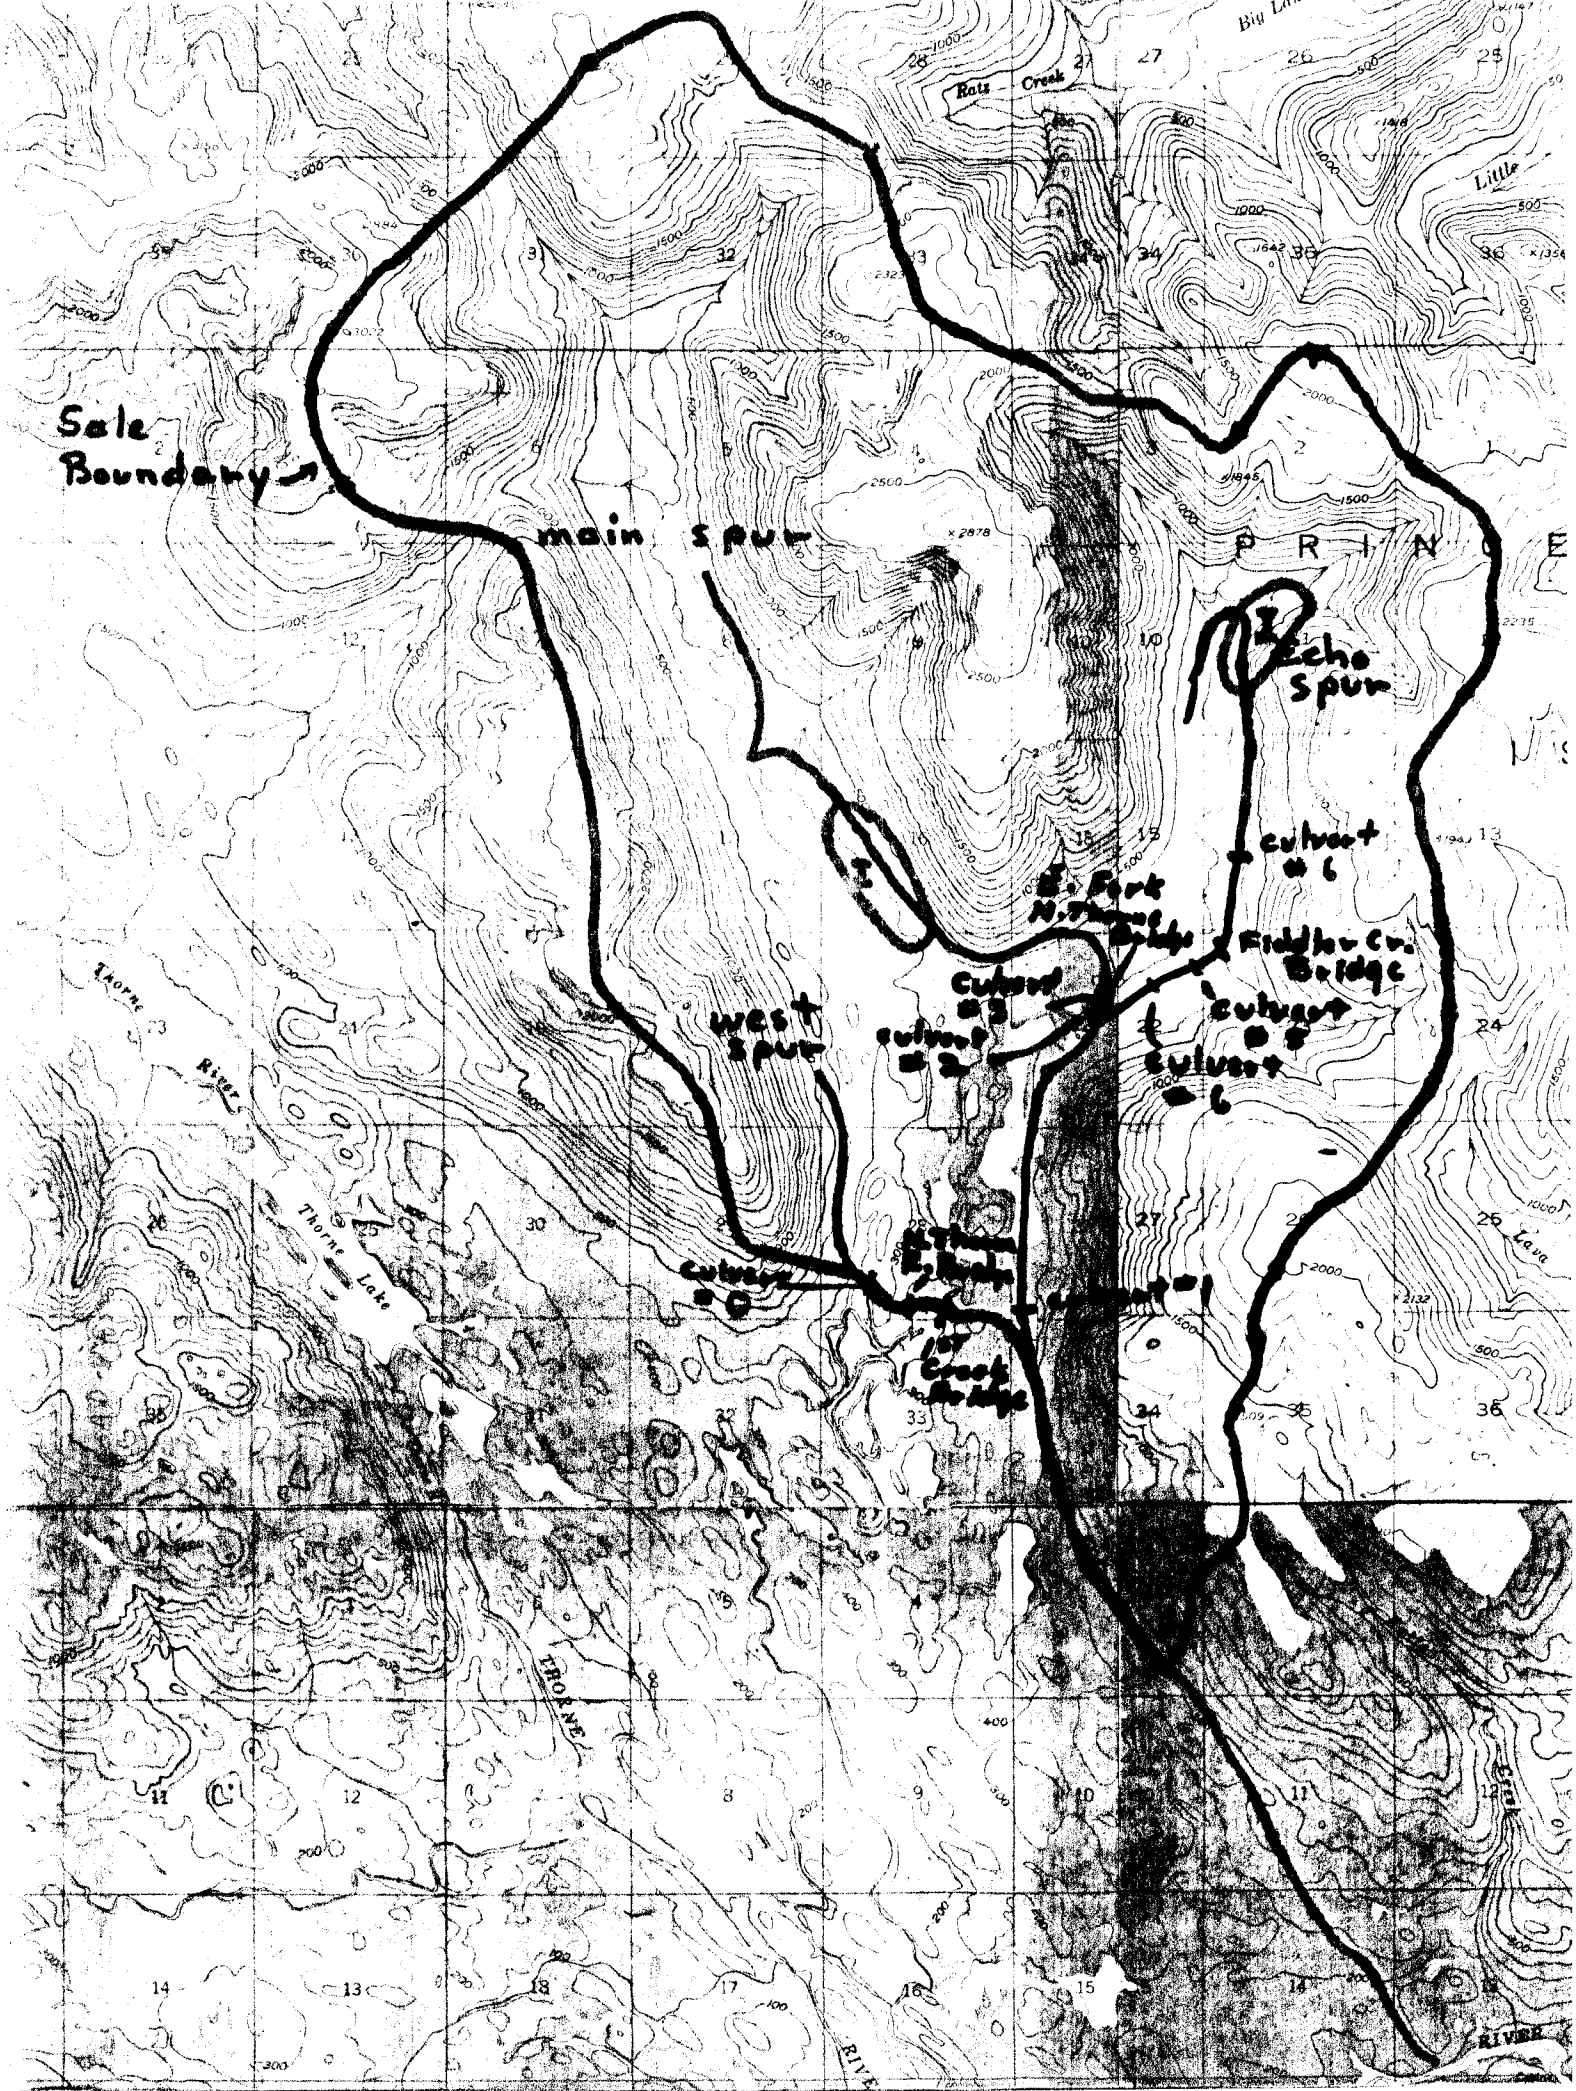
The two areas referred to above are shown on the enclosed map by the number 1. On both east fork and west fork these areas are bisected by access roads. We could not get up the main spur (west fork) far enough to see what the effect of the road placement has been due to a loading operation in the road. On Echo Spur the east branch of the east fork is very braided along the road. While this condition existed prior to road construction it is felt construction so close to the stream could trigger channel shifting. The road passes within forty feet of the stream for approximately 400 feet.

While logging has not occurred in the area requested to be deferred, road has been constructed near this section of unstable stream and the initial recommendation has only been partially effective.

Culvert number one was the only definite fish stream with evidence of logging accross it. Approximately 350 feet of stream is covered with debris from an older operation. This slash may be blocking the movement of Dolly Varden since fish were trapped up to a point about 100 feet below the culvert but none were found above the culvert. No natural barriers were observed from the culvert to where fish were trapped.

Culvert Number	Length of Trap set	Catch Above Culvert	Catch below Culvert	Description of Conditions
1	18 hours	0	0	3 cm drop, some scouring.
2	3.5 hours	0	1 D.V.	3 cm drop, no scouring.
3	13.5 hours	4 D.V.	0	No drop, silt & sand deposited to sides of culvert, 4 cm scour in front of culvert.
4	Non-fish stream	Not trapped		Loose rock and gravel on bank of stream capable of silt problem.
5	2 hours	0	0	10 cm drop. Slash and logs in stream just below culvert.
6	No set made			200 to 300 feet of channel that has been felled into and yarded across.
0	18 hours	0 (above road)	8 D.V. (below road)	No culvert here. Road has back up stream into woods.
